## Case 256 : Narrative

Case Vehicle (A): 2000 Ford	Vehicle (B): 1999 Ford
Type: Focus ZTS, 4-door sedan	Type: Contour SE, 4-door sedan
Driver: 33-year-old male	Driver: 45-year-old female
CDC: 11-FLEW-2	CDC: 99-0000-0

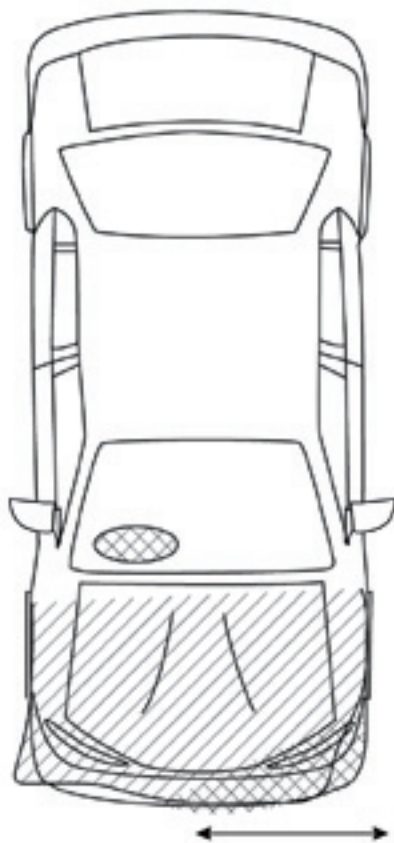
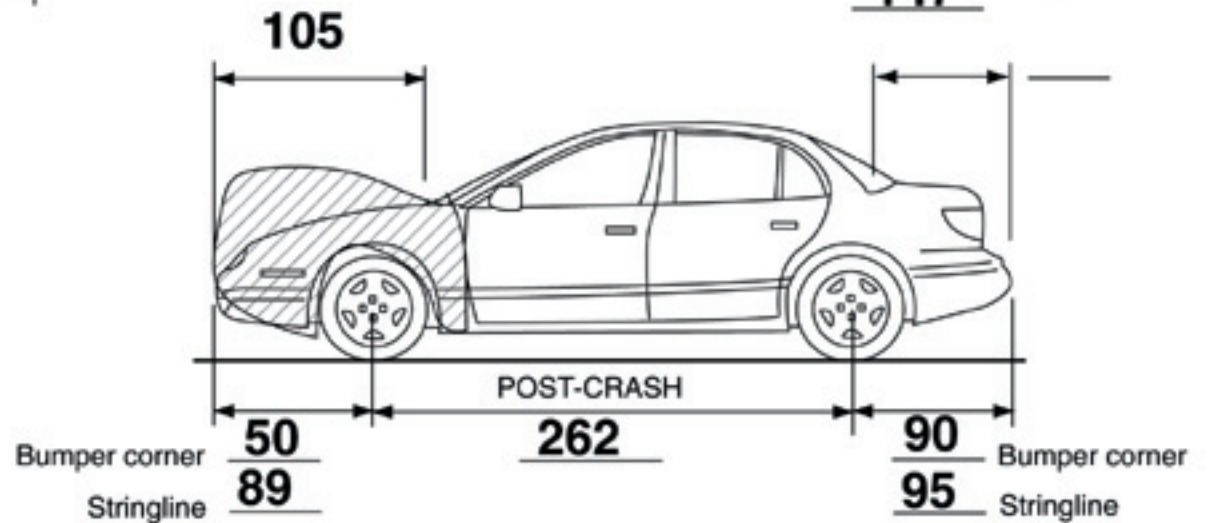
[4](#) The direct damage to case vehicle (A) began at the left-front bumper corner and extended 44 cm across the front, resulting in 37-percent vehicle overlap. The maximum crush was 33 cm to the left portion of the front bumper.

**direct damage**  
**max crush 33 cm**

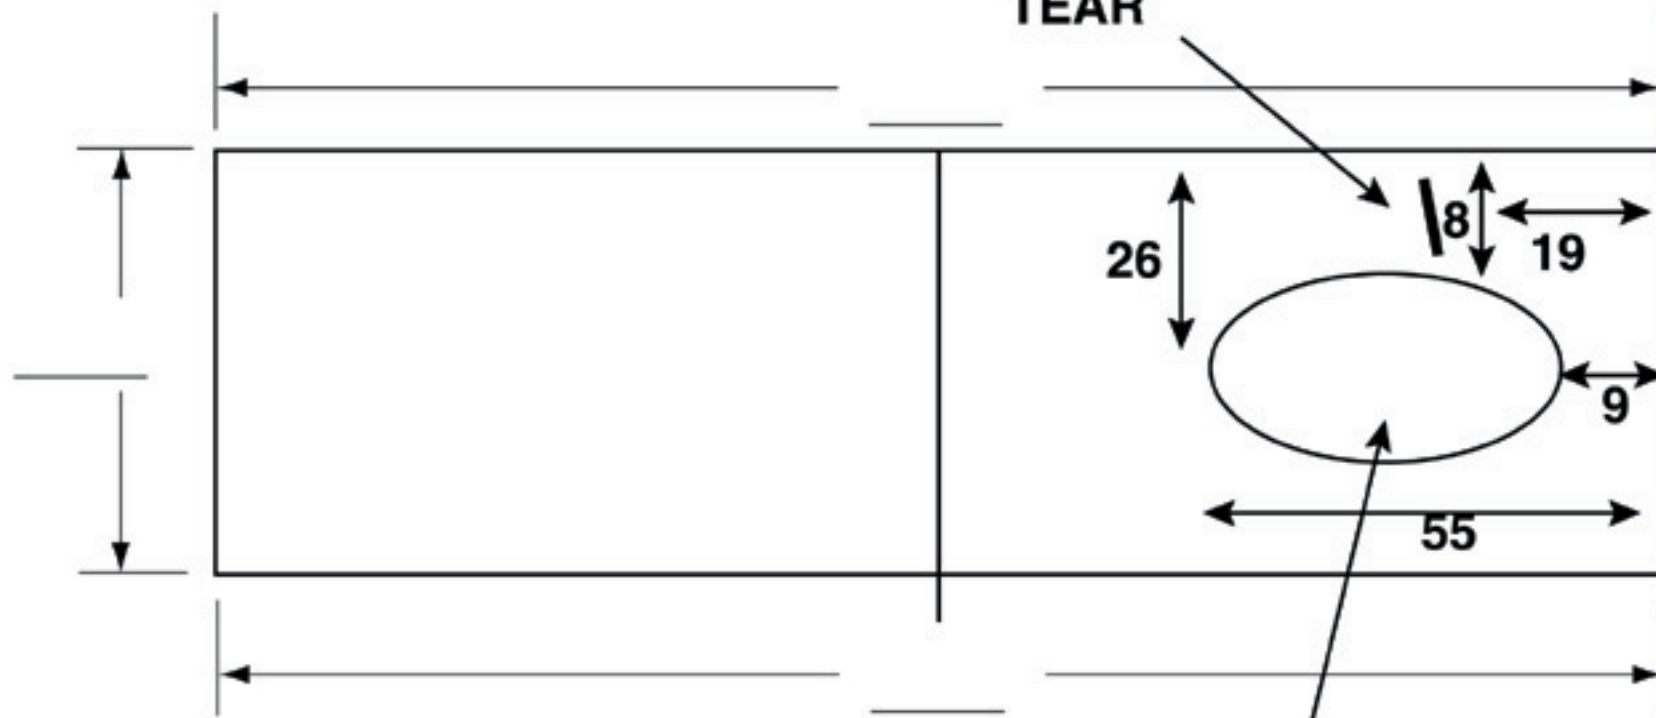
**PLASTIC INTERLAYER  
TEAR**

**CRACKED BY RIGHT-FRONT  
PASSENGER AIRBAG  
COVER**

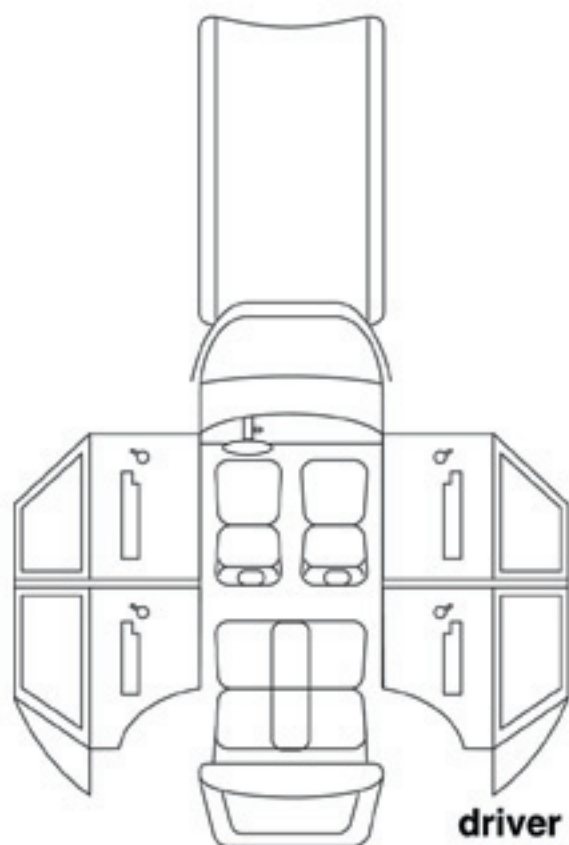
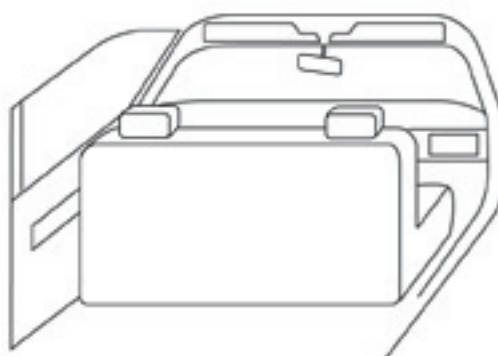
**driver belt: positioned "up" on B-pillar,  
pretensioner fired (4-cm long)**

**right front belt: positioned "up" on B-pillar,  
pretensioner not fired (12-cm long)**

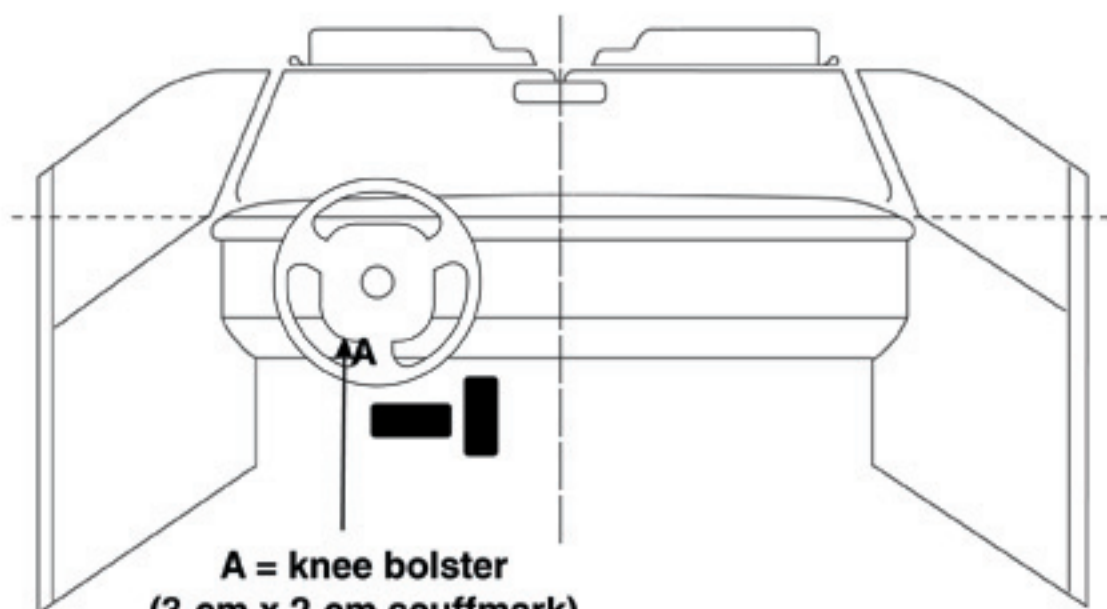
**A = knee bolster  
(3-cm x 2-cm scuffmark)**

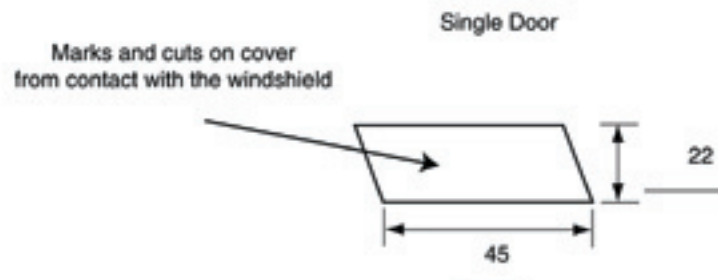
### Passenger Airbag Doors

Airbag cover and airbag skin contacted and cracked and holed the windshield
